LAKE AND RIVER ENHANCEMENT
DIAGNOSTIC STUDY
FOR
INDIAN CREEK WATERSHED

INDIAN CREEK WATERSHED
STEERING COMMITTEE

DONAN ENGINEERING, INC.,
4343 N. Hwy 231
Jasper, IN 47546
(812) 482 5611

January 26, 2001

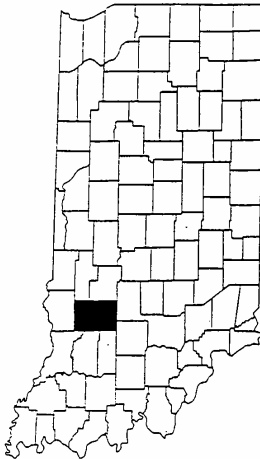
INDIANA FARM LAND USE HISTORY

Greene County, Indiana

Total Land Area 1992 - 346,967 Acres

Year	Land in Farms	Harvested Cropland	Land Pastured	Woodland Not Pastured
----- Acres -----				
1900	332,759	n/a	n/a	n/a
1910	315,073	n/a	n/a	n/a
1920	309,198	n/a	n/a	n/a
1930	276,353	98,781	111,371	12,175
1940	279,489	103,795	n/a	n/a
1950	281,305	118,859	107,206	22,691
1959	247,729	121,210	n/a	19,450
1964	226,003	100,172	n/a	18,428
1969	229,054	96,804	n/a	n/a
1974	214,619	103,279	n/a	n/a
1978	226,609	121,777	61,771	19,588
1982	210,812	121,314	52,853	18,793
1987	202,544	103,559	43,778	18,310
1992	207,766	117,268	43,987	23,773

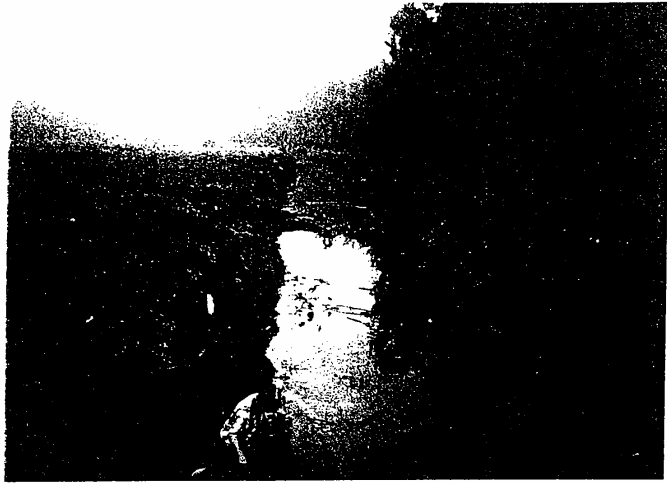
Site 1. Opossum Creek Tributary of Indian Creek.
The Indian Creek Study: Donan Engineering and
Indiana University Southeast. 1999
Downstream

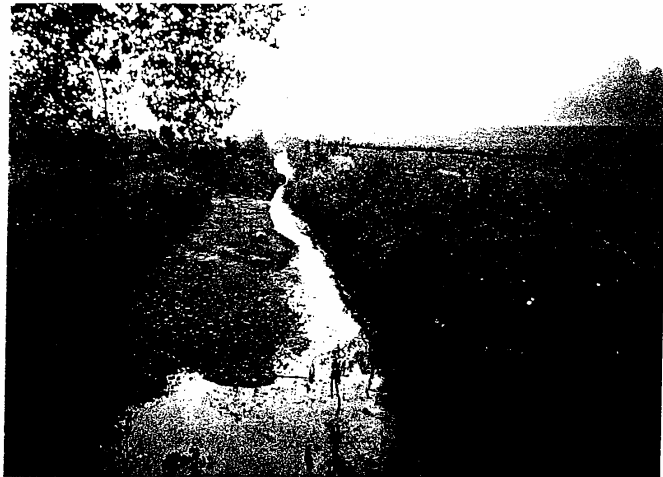
Site 1. Opossum Creek Tributary of Indian Creek.
The Indian Creek Study: Donan Engineering and
Indiana University Southeast. 1999
Field to Right Looking Upstream

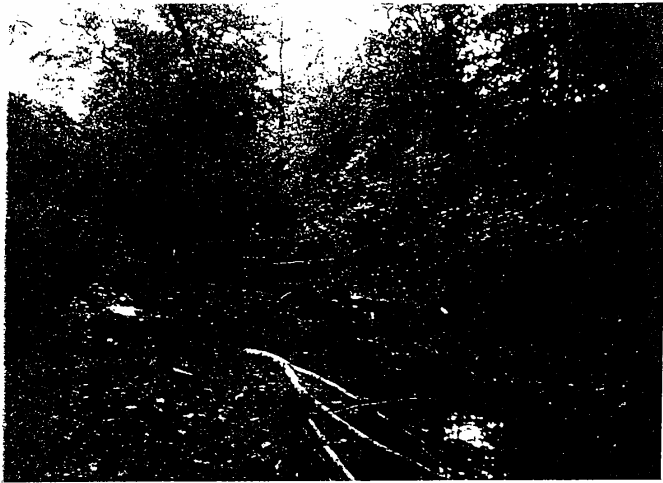
Site 2. Sulphur Creek. Tributary of Indian Creek.
The Indian Creek Study: Donan Engineering and
Indiana University Southeast. 1999
Downstream Riffle

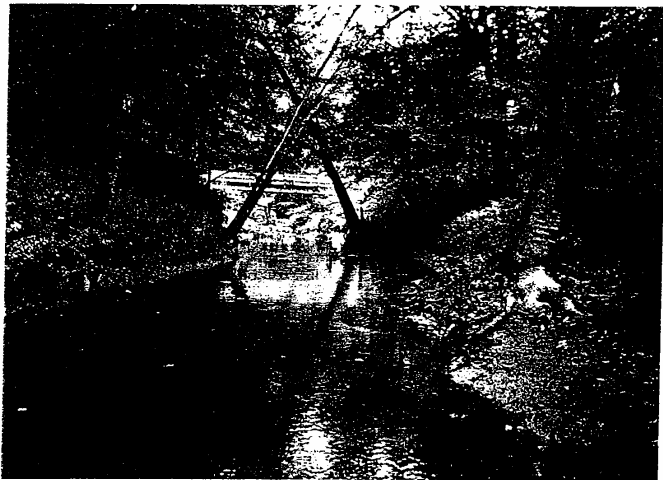
Site 2. Sulphur Creek. Tributary of Indian Creek.
The Indian Creek Study: Donan Engineering and
Indiana University Southeast. 1999
Upstream--Bridge in background

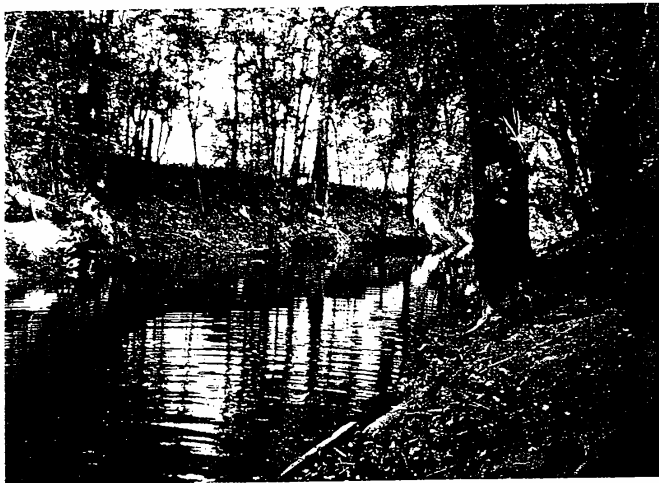
Site 3. Indian Creek Downstream.
The Indian Creek Study: Donan Engineering and
Indiana University Southeast. 1999
Upstream

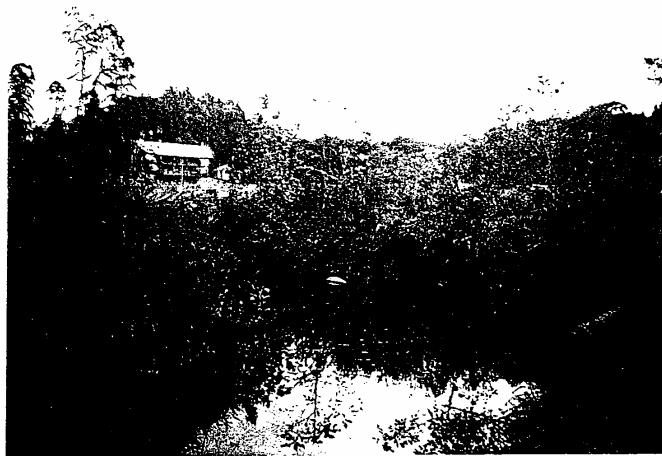
Site 4. Padanaram. The Indian Creek Study: Donan Engineering and Indiana University Southeast. 1999. Upstream with Typical Lodge in the Background.

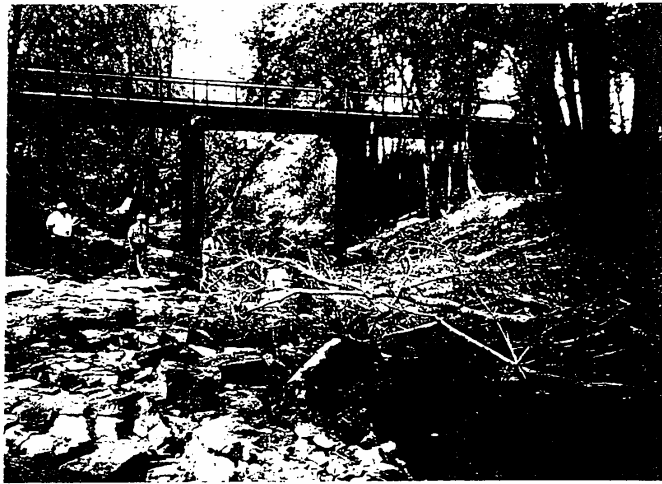
Site 5. Indian Creek near Indian Creek Church. The Indian Creek Study: Donan Engineering and Indiana University Southeast. 1999. Downstream with Bridge.

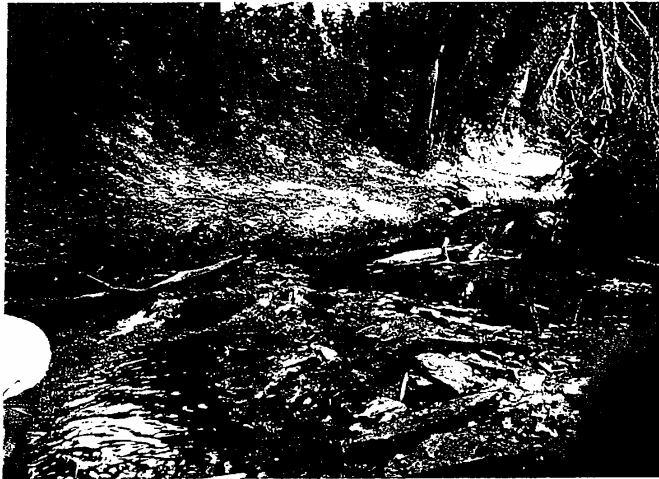
Site 5. Indian Creek near Indian Creek Church. The Indian Creek Study: Donan Engineering and Indiana University Southeast. 1999. Rifle.

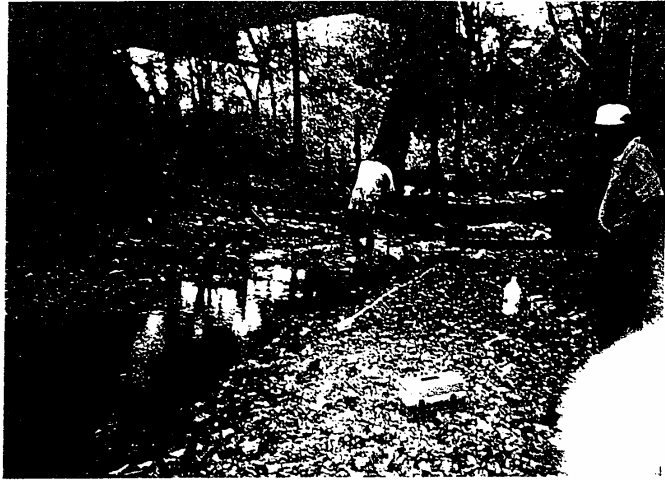
Site 6. Spring Creek.Tributary of Indian Creek. The Indian Creek Study: Donan Engineering and Indiana University Southeast. 1999. Riffle and Downstream. Beneath Existing Bridge.

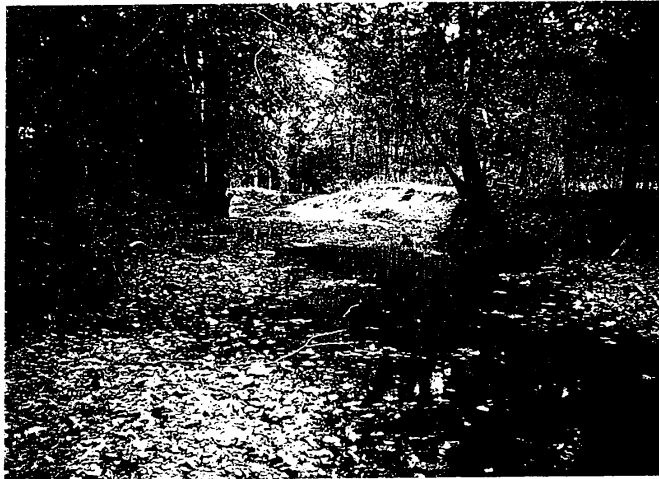
Site 6. Spring Creek.Tributary of Indian Creek. The Indian Creek Study: Donan Engineering and Indiana University Southeast. 1999. Upstream.

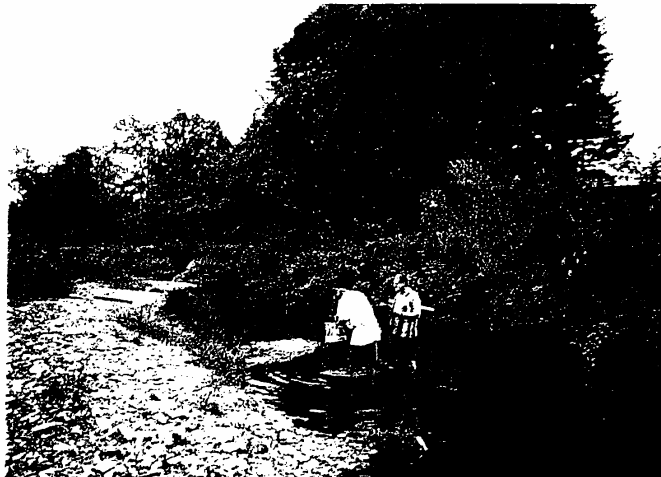
Site 7. Town Branch Tributary of Indian Creek. The Indian Creek Study: Donan Engineering and Indiana University Southeast. 1999. Bank Erosion.

Erosion of stream or riverbanks through lateral (side) erosion and collapse often causes high sediment loads in creeks and rivers. The problem is often initiated by heavy falls of rain in catchments with poor vegetation cover, causing excess run-off. The resultant high volume and velocity runoff will concentrate in the lower drainage lines or streams within catchments. When the stress applied by these stream flows exceeds the resistance of the local soil material, streambank erosion occurs. As the sediment load increases, fast-flowing streams grind and excavate their banks lower in the landscape. Later, the stream becomes overloaded or velocity is reduced, and deposition of sediment takes place further downstream. Streambank erosion is exacerbated by the lack of riparian zone vegetation and by direct stock access to streams.

In addition to loss of productive land due to bank erosion, dramatic changes in the course of a creek often restrict access on properties. Subsequent deposition of soil causes problems on productive land downstream and sedimentation in reservoirs. Other problems include reduction in water quality due to high sediment loads, loss of native aquatic habitats, damage to public utilities (roads, bridges and dams) and maintenance costs associated with trying to prevent or control erosion sites.

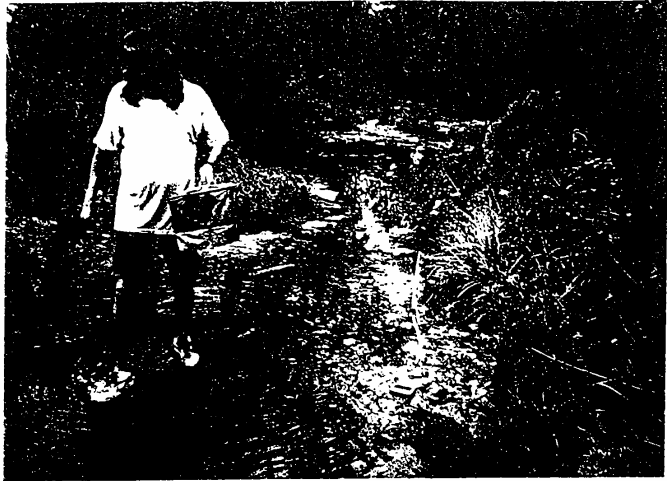
Site 8. Popcorn Creek Tributary of Indian Creek. The Indian Creek Study: Donan Engineering and Indiana University Southeast. 1999. Riffle Area over Bedrock.

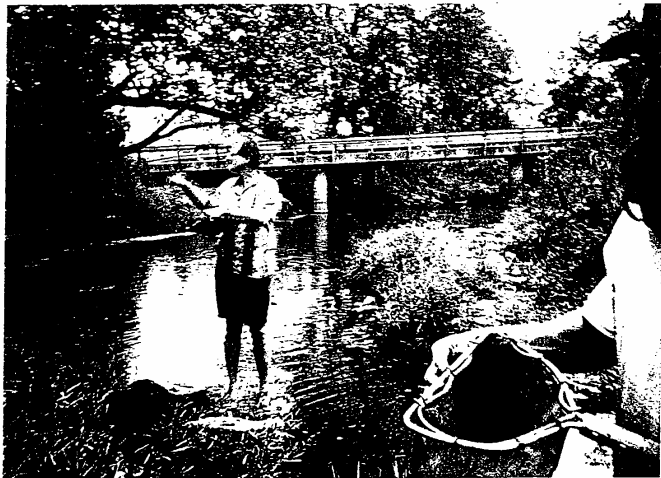
Site 8. Popcorn Creek Tributary of Indian Creek. The Indian Creek Study: Donan Engineering and Indiana University Southeast. 1999. Upstream. Bridge in the Background.

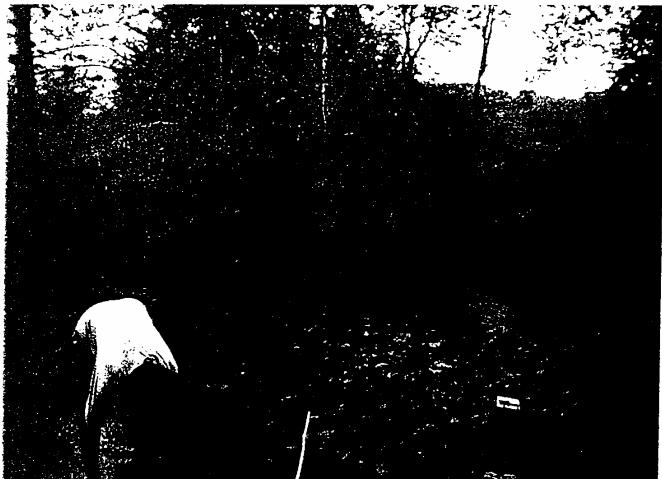
Site 9. Little Indian Creek Tributary of Indian Creek.
The Indian Creek Study: Donan Engineering and
Indiana University Southeast. 1999. Upstream.

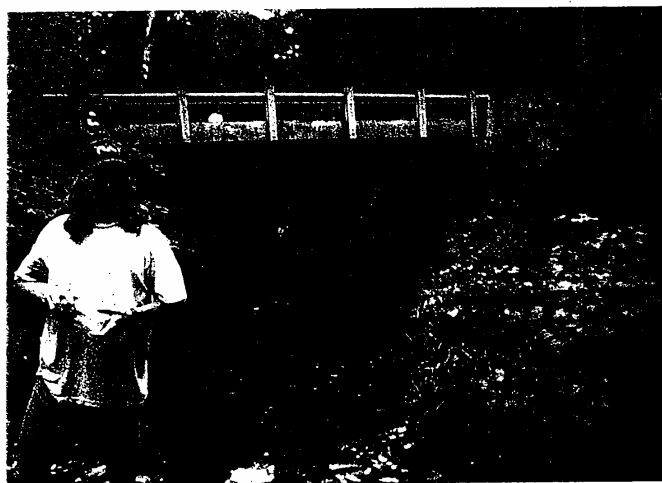
Site 10. Indian Creek The Indian Creek Study:
Donan Engineering and Indiana University Southeast.
1999. Upstream. Bridge in the Background.

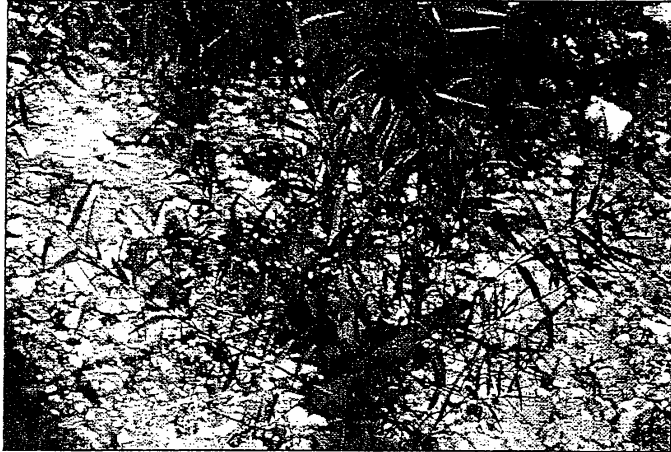
- DESCRIPTION**
- Live shrub or woody plant cuttings driven into the channel bank as stakes.

Exhibit 501a: Live Stakes (Source: NRCS Engineering Field Handbook)

PURPOSE	<ul style="list-style-type: none"> • To protect streambanks from the erosive forces of flowing water and to stabilize the soils along the channel bank
WHERE APPLICABLE	<ul style="list-style-type: none"> • Along streambanks of moderate slope, usually 4:1 or less. • Applicable in original bank soil, not on fill. • Useful where active erosion is light and washout is not likely. • Often applicable in combination with other vegetative or structural stabilization methods. • Applicable on all sizes of channels and all character types.
ADVANTAGES	<ul style="list-style-type: none"> • Economical, especially when cuttings are available locally. • Can be done quickly with minimum labor. • Results in a permanent, natural installation. • Improved riparian habitat
CONSTRAINTS	<ul style="list-style-type: none"> • Should be combined with other techniques such as vegetative stabilization (Practice 1102) or mulching (Practice 1101). • Does not provide initial surface protection until top growth has occurred. • Will be ineffective in areas of active erosion or on channels with high fluctuation of flows.

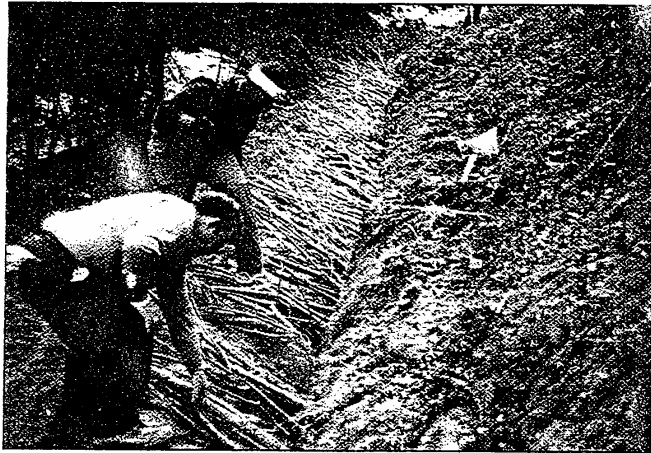
- Alternating layers of branches and soil incorporated into a hole or slumped out area in a slope or a streambank. Branches are used both underwater and above. The branches above the water line root to form a permanent installation while those below the water line provide initial stability.

Exhibit 503a: Branch Packings (Source: NRCS Engineering Field Handbook)

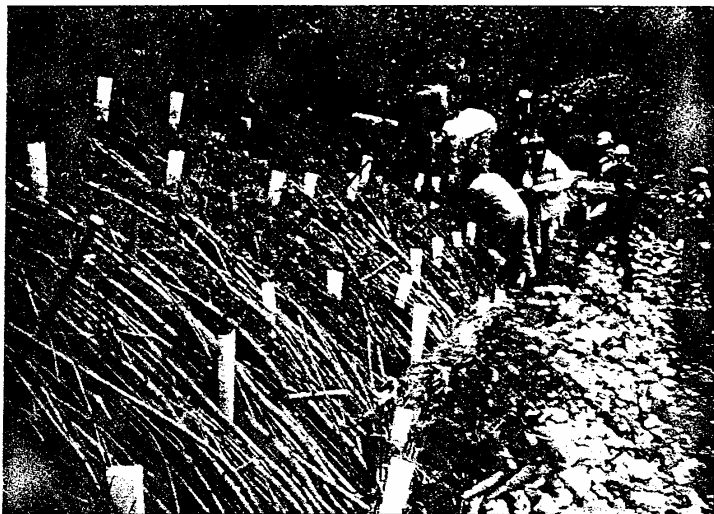
DESCRIPTION • Mat of live brush fastened down over an eroded bank.

Exhibit 505a: Brush Mattress (Source: NRCS files)

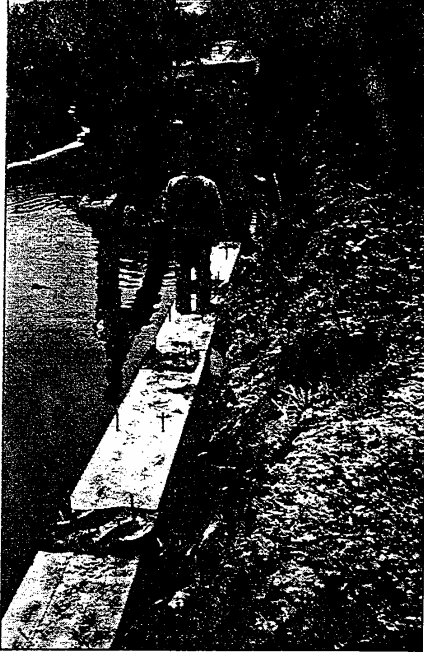
- DESCRIPTION**
- Oak or plastic (Eco-wood) rectangular boxes built into toe of bank to eliminate scour and provide fish habitat.

Exhibit 508a: Lunkers (Source: CBBEL Files)

PURPOSE	<ul style="list-style-type: none"> • Protect toe of bank and provide aquatic habitat.
WHERE APPLICABLE	<ul style="list-style-type: none"> • Undercutting at toe of bank. • Approximately 3:1 (1V:3H) slope. • Straight or curved sections.
ADVANTAGES	<ul style="list-style-type: none"> • Immediate erosion protection at toe of slope. • Provides habitat.
CONSTRAINTS	<ul style="list-style-type: none"> • Labor intensive. • Requires equipment for excavating and backfilling.
DESIGN AND CONSTRUCTION GUIDELINES	<p>Materials</p> <ul style="list-style-type: none"> • Eco-wood or oak lunker. • 5/8" rebar in 5' lengths (9 per lunker) • Geotechnical fabric. • Live Stakes (Practice 501). • Vegetative Stabilization (Practice 1102).

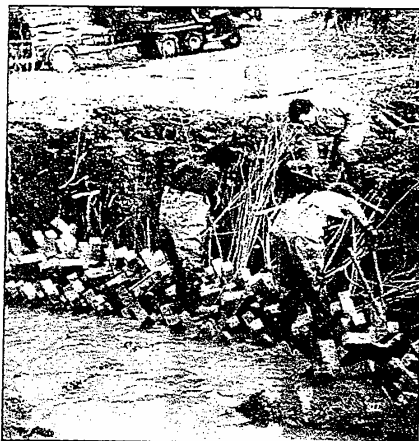
- DESCRIPTION**
- Concrete, jack-like structures set at toe of bank. Often integrated with live stakes and other vegetative stabilization techniques.

Exhibit 509a: A-Jacks Installation (Source: Illinois State Water Survey Publication)

PURPOSE	<ul style="list-style-type: none"> To protect streambanks from the erosive forces of flowing water and to stabilize the soils along the channel bank.
WHERE APPLICABLE	<ul style="list-style-type: none"> Along eroded toe. Low to high velocity areas. Scour holes.
ADVANTAGES	<ul style="list-style-type: none"> Protects soil from scour during plant propagation. Provides erosion control protection even if vegetation does not become established. Immediate erosion protection at toe of slope. Improves aquatic and wildlife habitat.
CONSTRAINTS	<ul style="list-style-type: none"> Labor intensive. Must be used in conjunction with vegetative stabilization.
DESIGN AND CONSTRUCTION GUIDELINES	<p>Materials</p> <ul style="list-style-type: none"> 2' A-Jacks. Live Stakes (Practice 501). Fiberdam - geotechnical material. Vegetative Stabilization (Practice 1102). Suitable backfill.

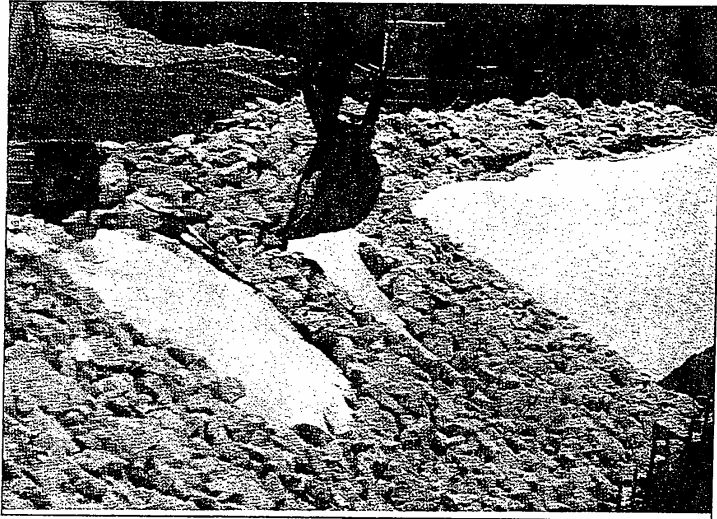
- Covering of a portion of a channel bank with a layer of stone that approximates the natural slope of the channel bank. (Note: This practice is also included in the Indiana Erosion Control Handbook.)

Exhibit 510a: Stone Riprap (Source: North Carolina Erosion Control Manual)

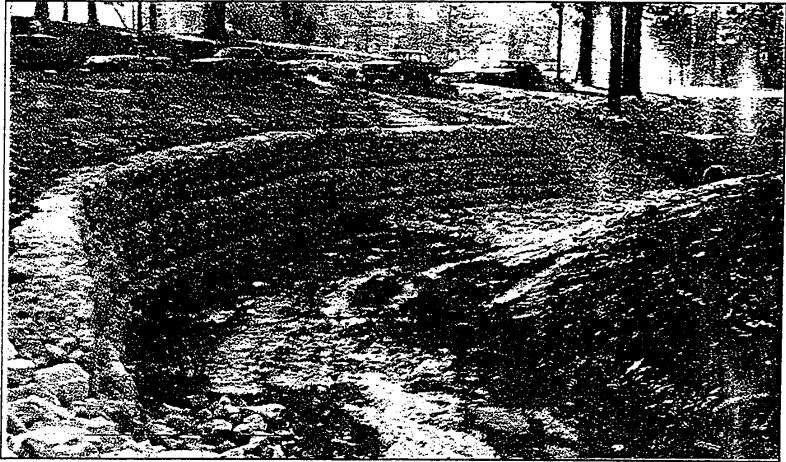
- DESCRIPTION**
- Rock-filled baskets of wire or plastic. Baskets are wired together to form a wall or mattress for erosion control along a bank or channel.

Exhibit 512a: Gabion Retaining Wall (Source: North Carolina Erosion Control Manual)
